# Central Park Tower

## Building Condition Documentation

1511 Farnam Street, Apt. 110  
Omaha, Nebraska 68102

Documented: October 30, 2026

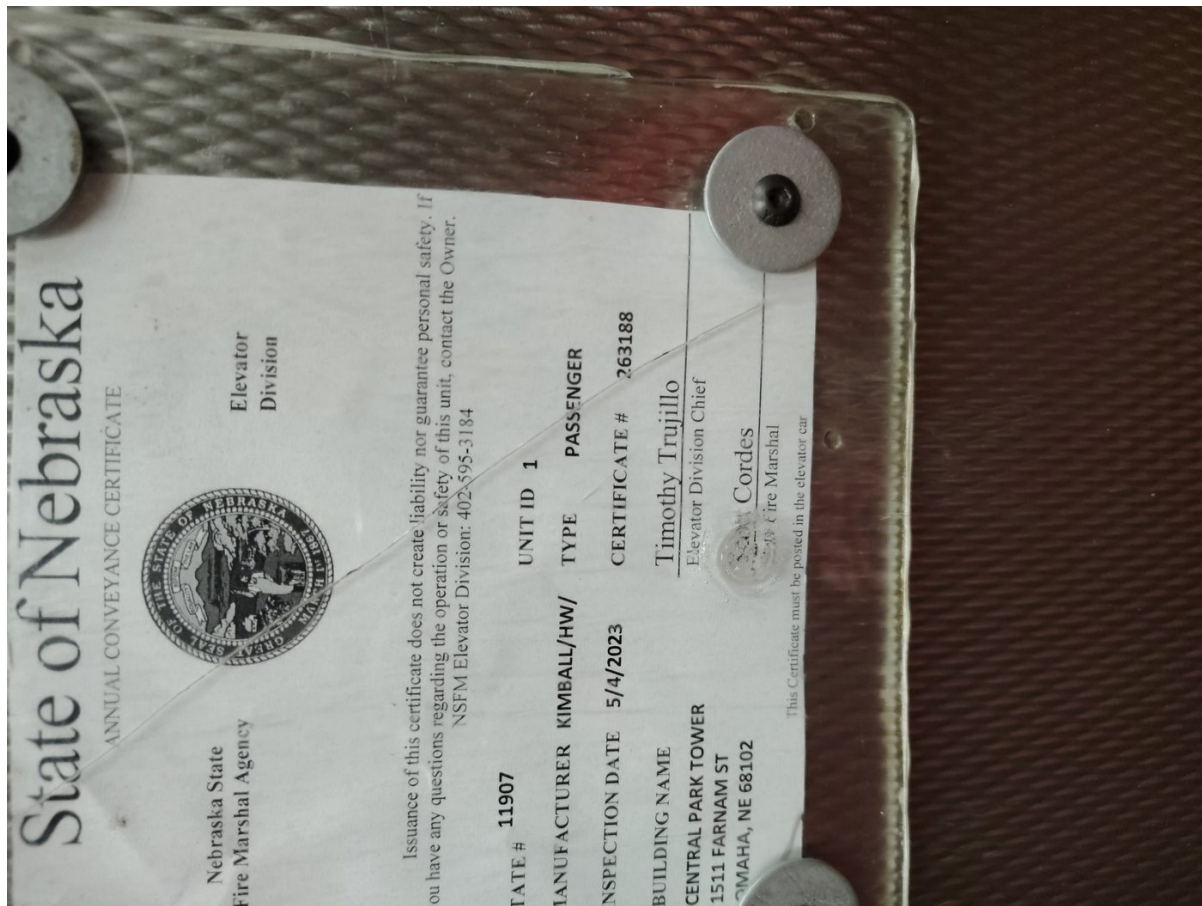
The Annual Conveyance Certificate posted in the elevator car was issued by the Nebraska State Fire Marshal Agency, Elevator Division. The certificate shows an inspection date of May 4, 2023.

Figure 1: Nebraska State Fire Marshal Agency Annual Conveyance Certificate posted in the elevator car at Central Park Tower. Inspection date: May 4, 2023. Certificate #263188. Unit ID 1, passenger elevator, manufacturer Kimball/HW/. Building address listed as 1511 Farnam St, Omaha, NE 68102.

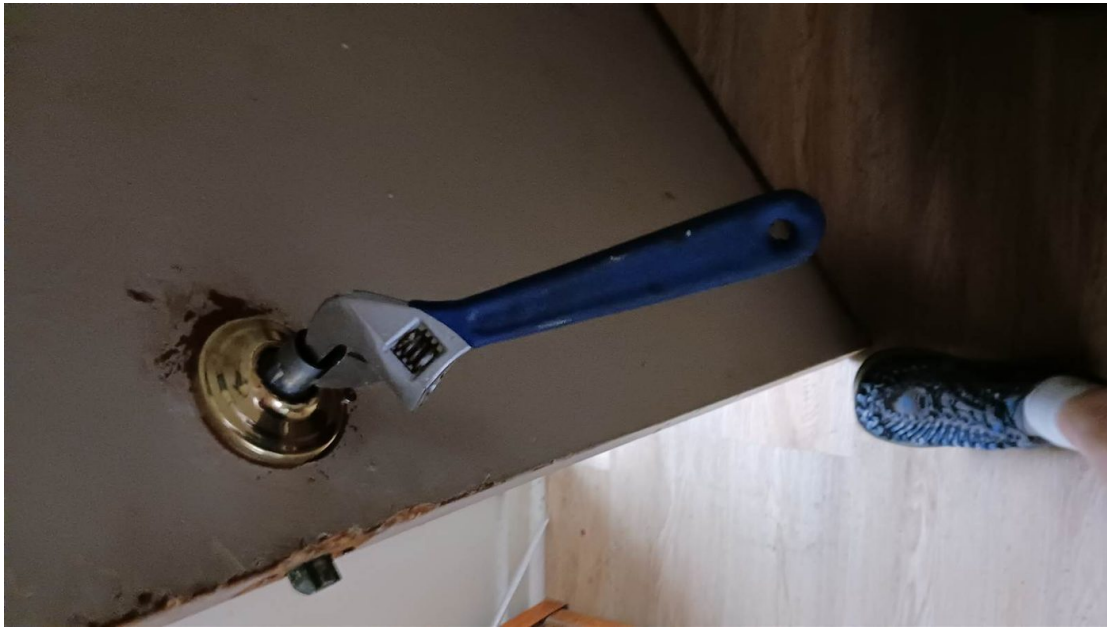
A door at the property is missing its knob. An adjustable wrench is positioned on the remaining brass escutcheon/hardware.

Figure 2: Door missing its knob, with an adjustable wrench applied to the remaining brass hardware. Wear and damage are visible along the door edge.

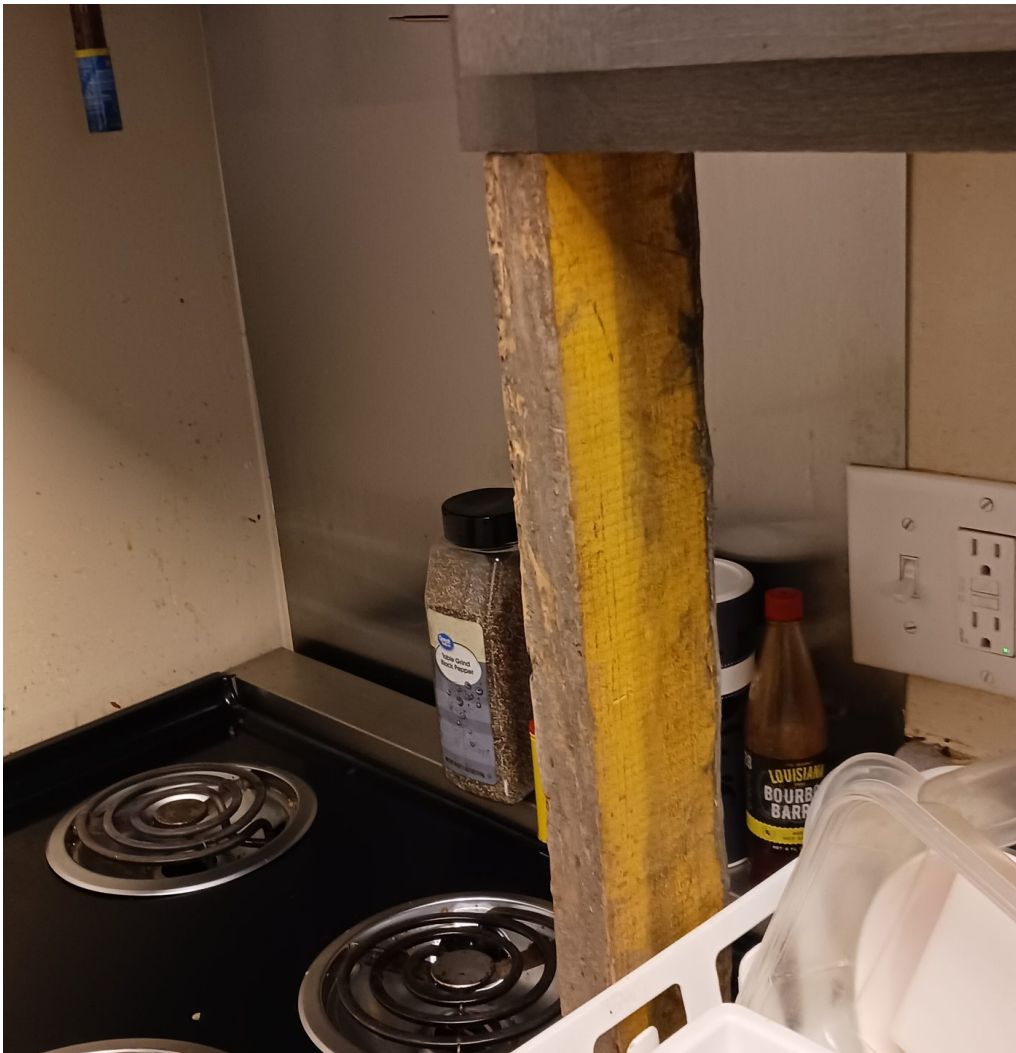
An upper cabinet or shelf is supported by a rough wooden plank positioned directly above an electric range.

Figure 3: Rough wooden plank (with yellow marking) propping up an upper cabinet/shelf immediately above an electric stove at Central Park Tower. The support is in the cooking area.

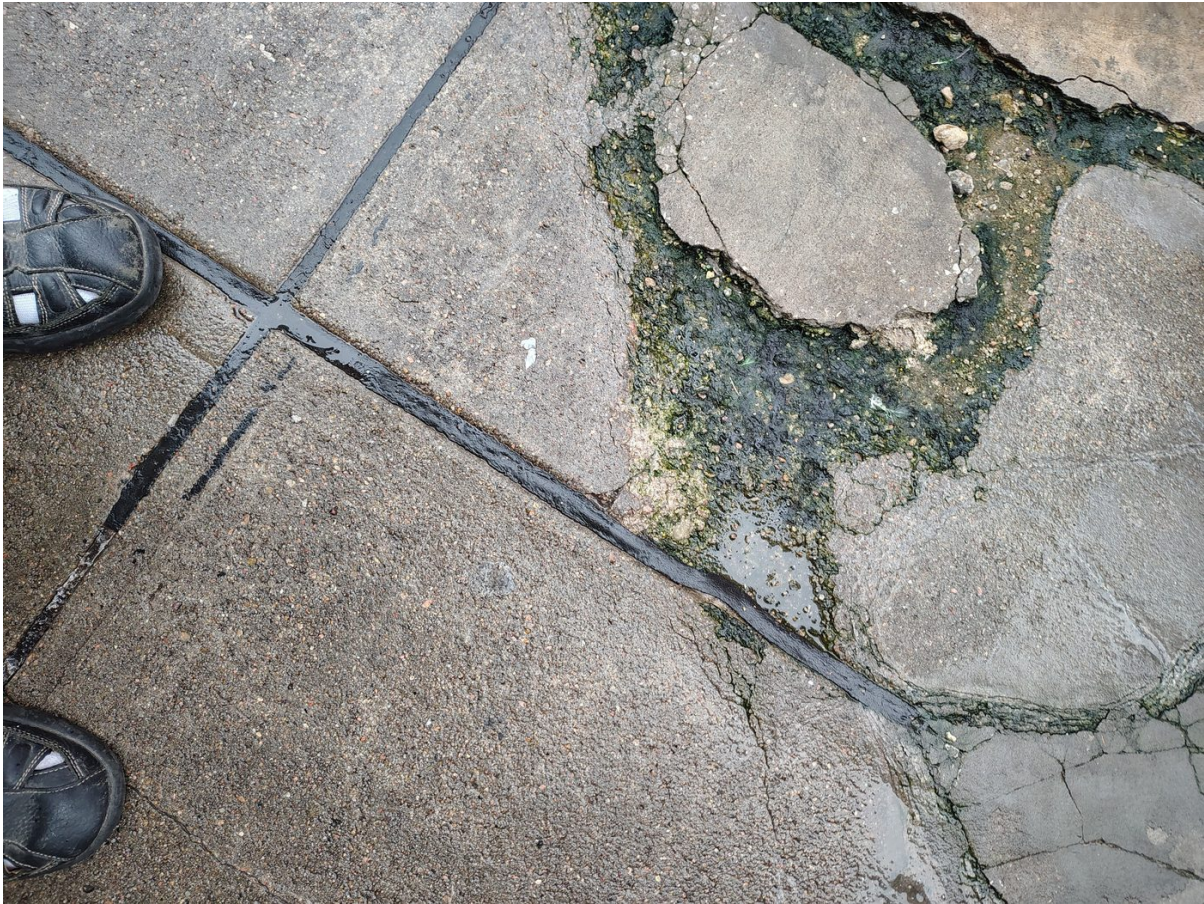
The exterior sidewalk shows extensive deterioration, including missing concrete sections, cracking, standing water, and surface growth.

Figure 4: Deteriorated exterior sidewalk at Central Park Tower showing missing concrete, cracks, standing water, and surface growth. The condition creates trip and accessibility hazards.
