**Life-safety complaint: locked and blocked exit doors**

Central Park Tower, 1511 Farnam Street, Omaha, Nebraska 68102

Photographs taken October 5, 2026. Submitted to the Omaha Fire Department and the Nebraska State Fire Marshal.

Re: Padlocked exit hardware and a door marked "NOT AN EXIT"  
Central Park Tower, 1511 Farnam Street

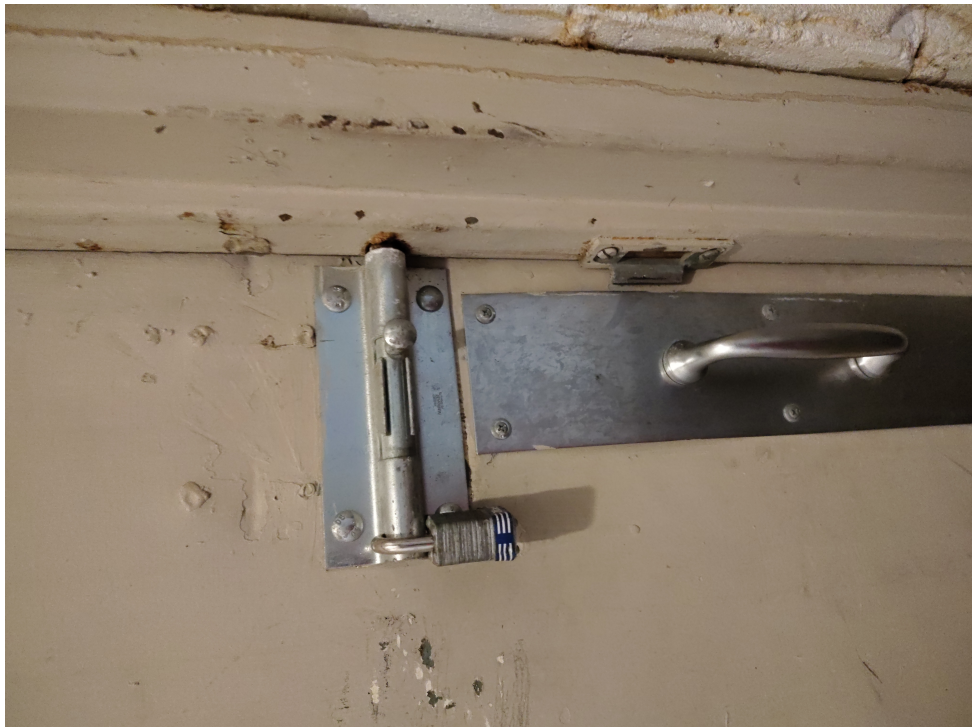
Figure 1: Slide bolt closed through the hasp and held by a padlock. A pull handle is on the same door. The padlock is on the occupied side of the door. Photograph, October 5, 2026, Central Park Tower.

The first photograph shows a surface slide bolt driven into the strike, with a padlock through the staple. A handle plate is screwed to the same door. From this side, the door does not open without the key to that padlock. Exit hardware has to operate without a key, tool, or special knowledge. A padlock on the egress side is the opposite of that rule.

1. Inspect these doors and say which are required exits.
2. Order removal of any padlock, slide bolt, or hasp on the egress side of a required exit.
3. Test the panic bar on the door signed “STAIRWAY / LOBBY” from the stair side.
4. Say whether the door signed “NOT AN EXIT” may remain signed and hasped, or whether the sign is being used on a former exit.

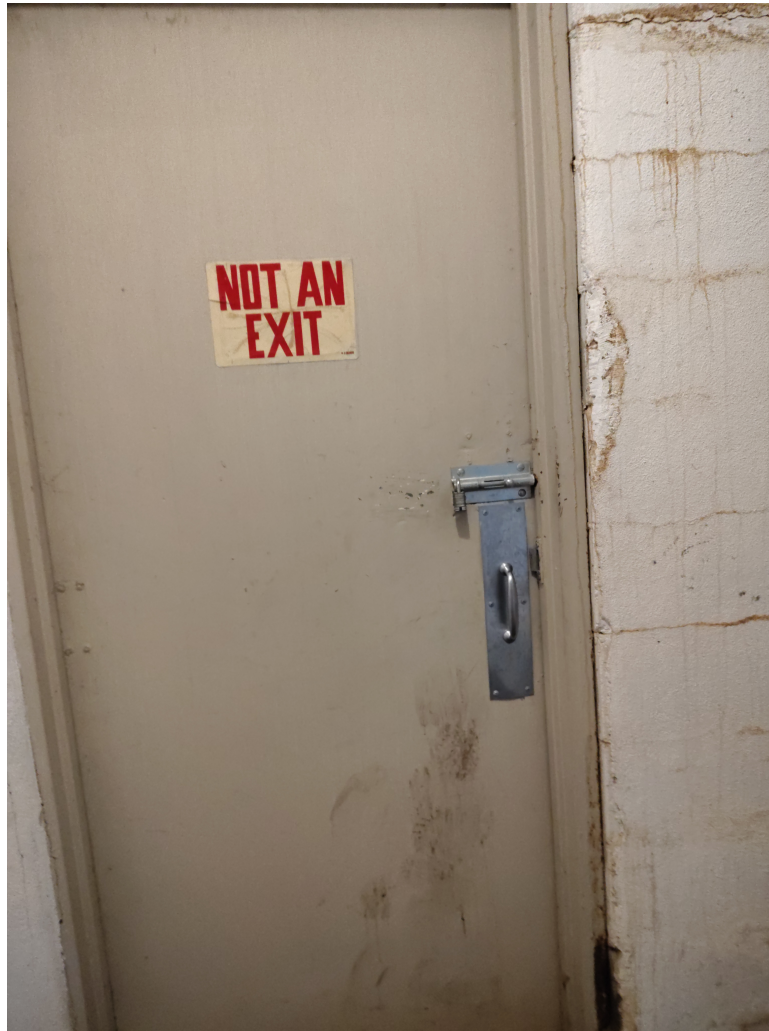
Figure 2: Door with a paper sign reading “NOT AN EXIT,” and a hasp mounted on the occupied side. Photograph, October 5, 2026. The file labeled rooftopdoorblocked.jpg is the same door.

The second photograph is a door in the same stair or landing, signed “NOT AN EXIT,” with a hasp on the occupied side. A sign does not make a door legal if the door is a required exit, or if the hardware still blocks the swing. The hasp is the same type as the padlocked bolt in the first photograph. Please determine whether this door was a required exit to the roof or to grade, and whether the hasp is permitted.

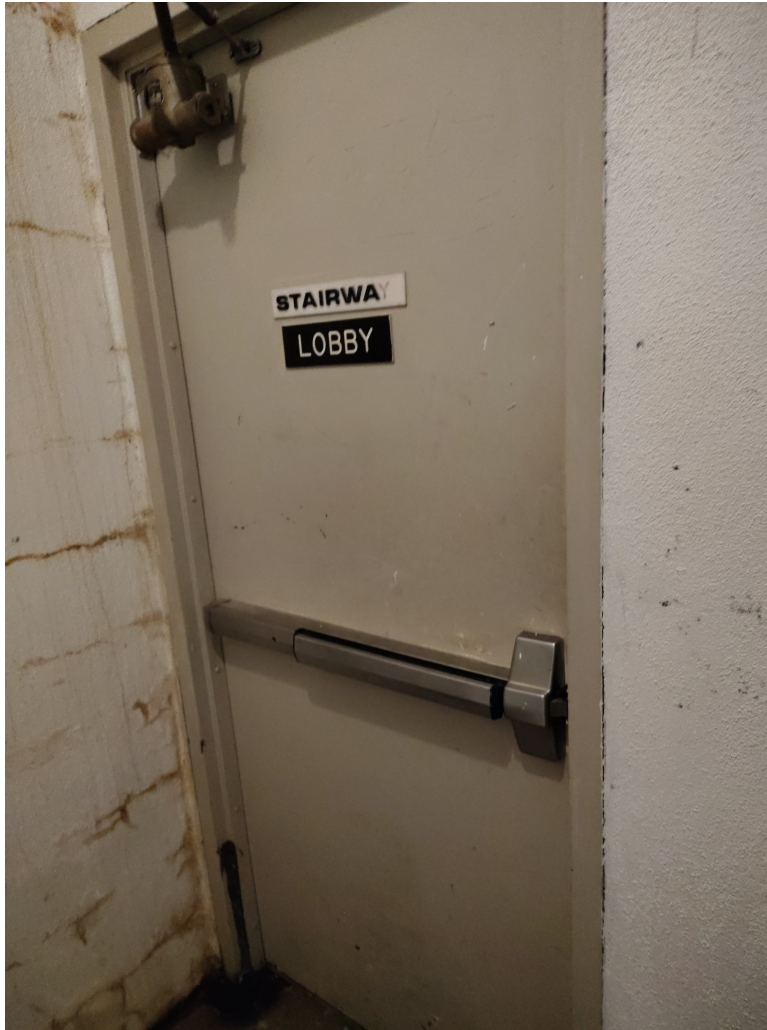
Figure 3: Door signed “STAIRWAY” and “LOBBY,” with a panic bar. A closer or alarm device is at the top of the frame. Photograph, October 5, 2026, Central Park Tower.

The third photograph is the door signed “STAIRWAY” and “LOBBY.” It has a panic bar. The bar is the correct type of hardware only if it opens the door in one motion and the door is not otherwise bolted. Please test this door from the stair side. The device at the top of the frame should be identified. Paint is failing on the block wall beside the frame.
